RECENT RESEARCH ACTIVITIES AT THE DEPARTMENT OF STEEL STRUCTURES, UACEG, SOFIA

The paper presents two recent research projects carried out in the testing laboratory at the Department of Steel Structures in Sofia.

1. PART I: EXPERIMENTAL STUDY OF PARTIALLY ENCASED I-BEAMS

2. PART II: EXPERIMENTAL INVESTIGATION OF COLUMN BASES LOADED IN SHEAR

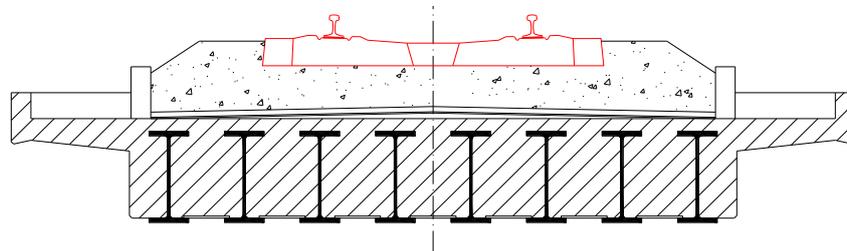
Fig. 1: Typical filler beam deck

Steel and concrete are the two primary structural materials in modern construction, and in many cases they are combined to work together as for example in the classical reinforced concrete, as well as in the composite steel-concrete structures. The reliable shear connection between the two component materials plays a key role, and therefore various methods and different shear connectors have been proposed. On the other hand a possible solution is to use the natural bond between steel and concrete [1], as for example the so-called ‘cased beams’ considered in BS5400: Part 5 [2]. However, Eurocode 4: Part 2 [3] presumes use of shear connectors for composite beams. On the other hand, as an exception, the specific case of filler beam decks is included in [3] in which the composite action relies entirely upon the natural bond (*Fig. 1*).

The design of this system presumes a full interaction between steel and concrete which is guaranteed by specific requirements imposed by the code. Steel beams may be hot-rolled profiles or welded girders, spaced at maximum 750 mm on centre. The structure is applicable both for road and for railway bridges. Special design guidelines have been issued by UIC [4].

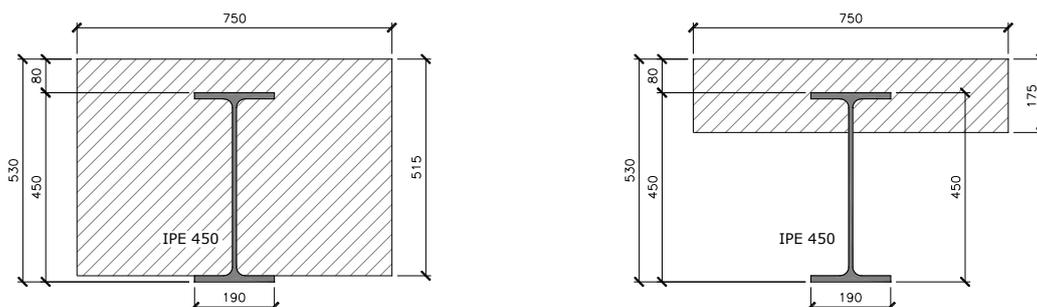
Fig. 2: Cross-sections: original filler beam and modified partially encased beam

In this part of the paper a study is reported on a modification in which the steel beams are only partially encased; the ‘useless’ concrete in the tension zone (for positive bending moments) is removed thus reducing the weight and mass of the whole structure (*Fig. 2*).

It is believed that in this manner the above mentioned advantages are preserved. Another advantage may also be found in the fact that the holes for the reinforcement bars are moved to the compression zone or close to the neutral axis of the cross-section, thus enhancing the fatigue behaviour. Additionally, possible dowel action of the transversal rebar may contribute to the composite performance of the beams.

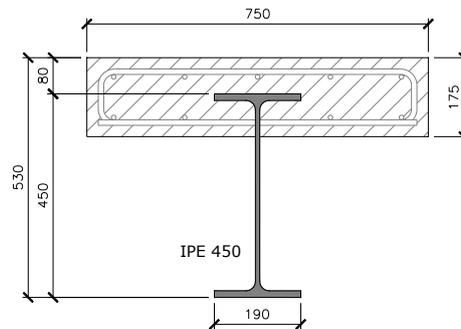
Fig. 3: Cross-section of tested partially encased beams

In this experimental study four partially encased beams have been tested. The specimens are full-scale, composed of IPE450 profiles of steel grade S275, partially encased in R/C slab of concrete C25/30. The beam cross-section is shown in the following Fig. 3.

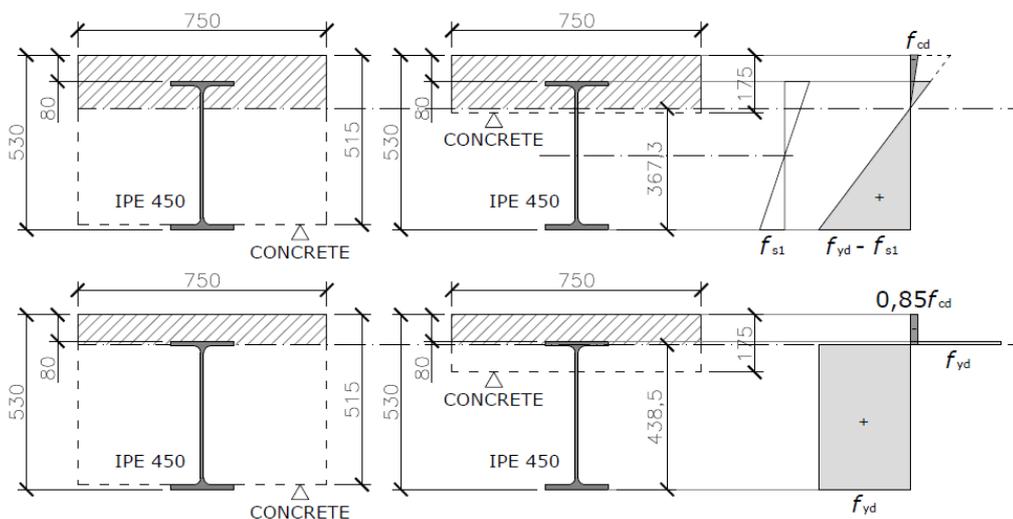
Fig. 4: Models for elastic and plastic design resistance

The test beams have been designed using the models of Eurocode 4 [2], assuming full interaction connection (Fig. 4). For comparison, the ‘original’ filler beam section is included in the figure to illustrate that, due to the position of the neutral axis both cross-sections have the same elastic and plastic design resistance.

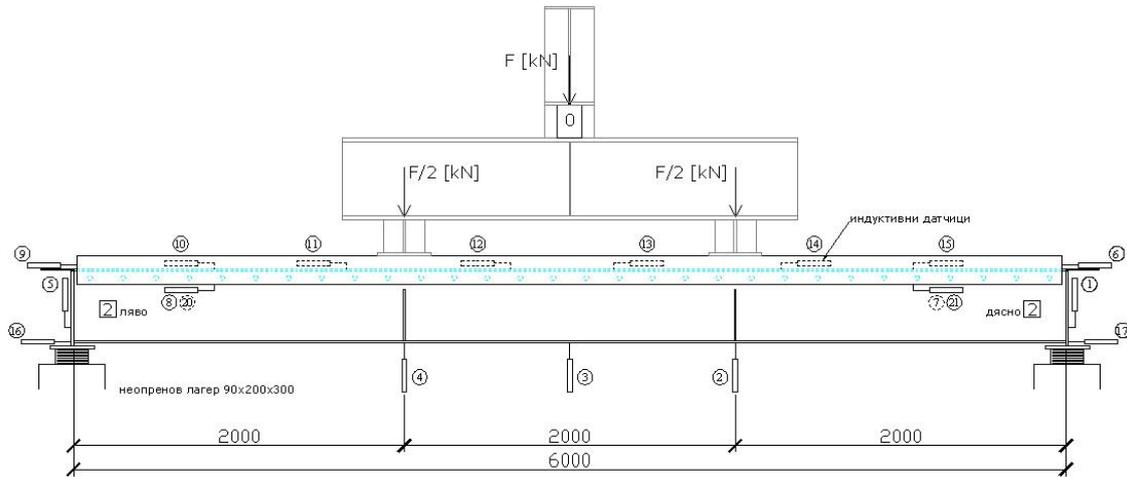
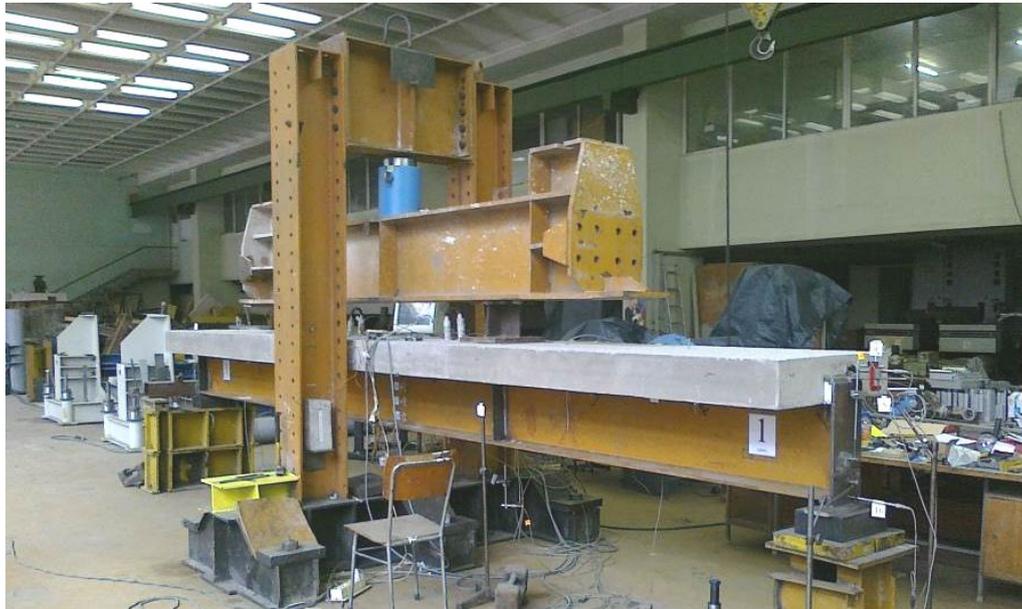
Fig. 5: Experimental setup

The experimental setup is illustrated in *Fig. 5*. The load is applied by a hydraulic jack and a load-distributing beam. Elastomeric bearings are used at the supports. Inductive displacement transducers are installed as shown in the figure. The strain gauges in the middle cross-section are shown in *Fig. 6*.

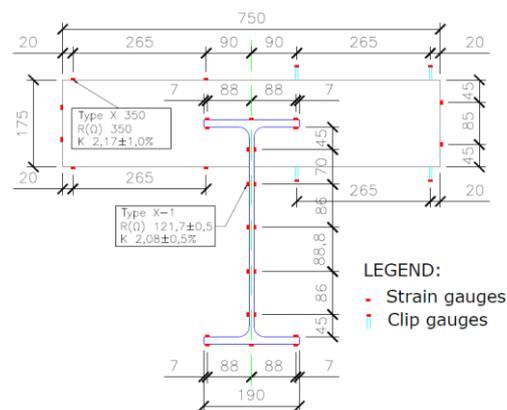
Fig. 6: Strain gauges pattern in the middle cross-section

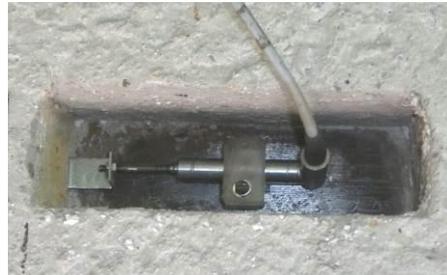
Fig. 7: Setup for concrete-to-steel slip measurement

To investigate the behaviour of the concrete-to-steel shear connection, the slip is measured by inductive displacement transducers located in special openings in the concrete slab as shown in *Fig. 7*.

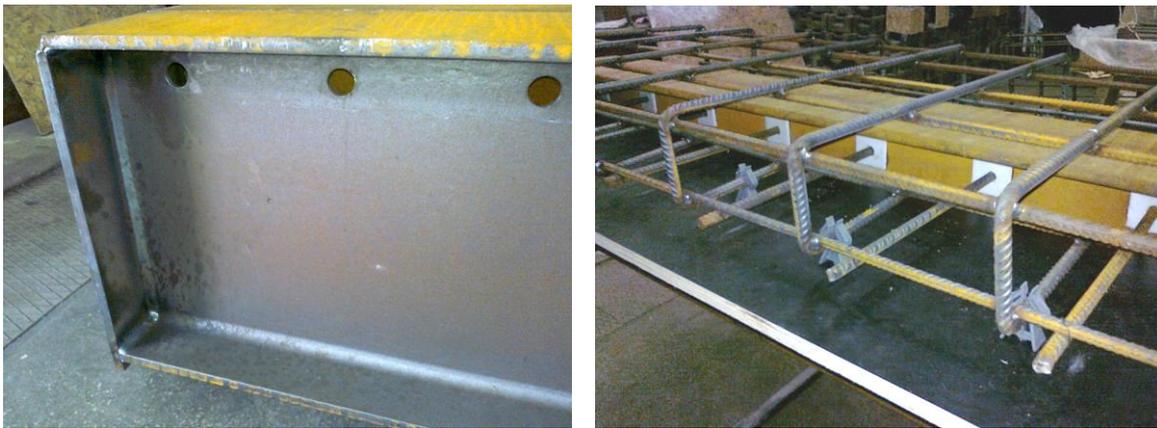
Fig. 8: Reinforcement details of test specimens

A total of four specimens have been tested. However, due to the symmetry of the setup it may be considered that actually 8 equivalent specimens have been studied. In two of the specimens (O1 and O2) the reinforcing bars, crossing the beams through holes in the web, have been deliberately ‘isolated’ to avoid any dowel effect (*Fig. 8*), while in the rest two specimens (O3 and O4) no special care has been taken in that context.

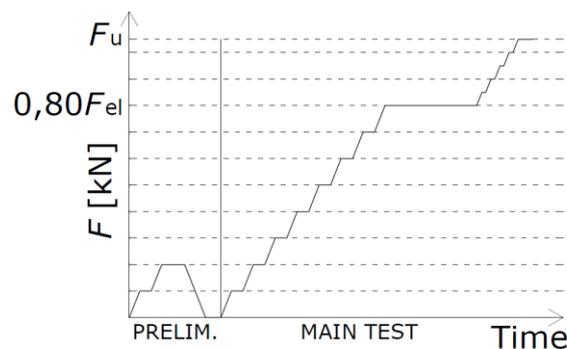
Fig. 9: Loading protocol

The loading protocol is illustrated in *Fig. 9*. After a preliminary heat-up, the specimens were loaded monotonically with steps of $0,10F_{el}$ (F_{el} being the force corresponding to the calculated elastic bending resistance) until $0,80F_{el}$ was reached, with 20 min time intervals. On reaching $0,80F_{el}$, 2–3 hours pause was made, and the loading continued with smaller steps ($0,05$ to $0,02 F_{el}$) until failure.

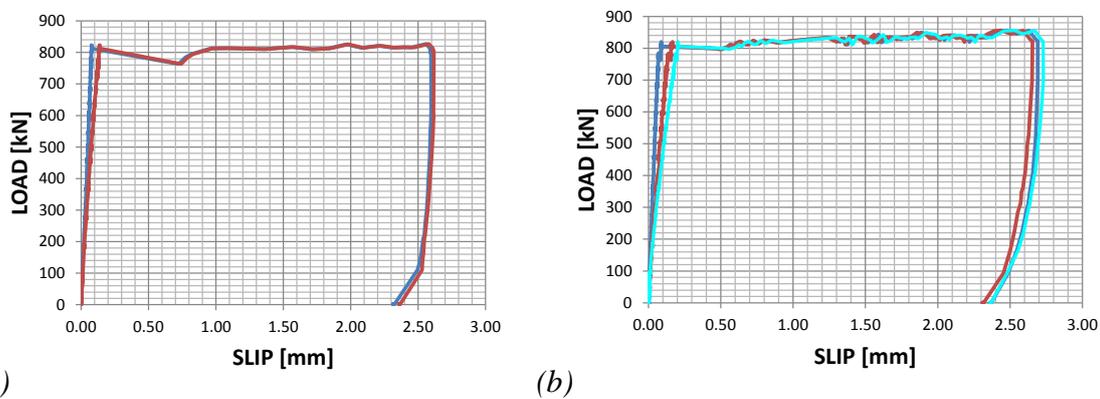
Fig. 10: Typical experimental load–slip curves for (a) specimen O1 (‘isolated’ rebars) and (b) specimen O4 (‘non-isolated’ rebars)

Within the focus of the investigation, the most interesting test results are those concerning the behaviour and the ultimate capacity of the natural adhesive bond between the concrete slab and the steel beam, and its effect on the behaviour and the bending resistance of the partially encased composite beams. Typical experimental load-slip curves are shown in *Fig. 10* for both types of specimens. A very interesting observation is well seen in the figure that the failure of the bond does not lead to significant degradation of the resistance. Indeed, in the case of deliberately ‘isolated’ reinforcement, just after the ‘loss’ of bond connection some drop in strength appears, however it is quickly compensated, and the final curve becomes quite similar to the other specimen type. Therefore, despite the fact that the effect of the dowel action of the reinforcement appears negligible, this effect seems to contribute to a ‘smoother’ transition after the failure of the adhesive bond. Nevertheless, the plateau in the curves demonstrates that the reached load and the corresponding resistance remain constant until large deformations when further increase of the applied load becomes practically impossible.

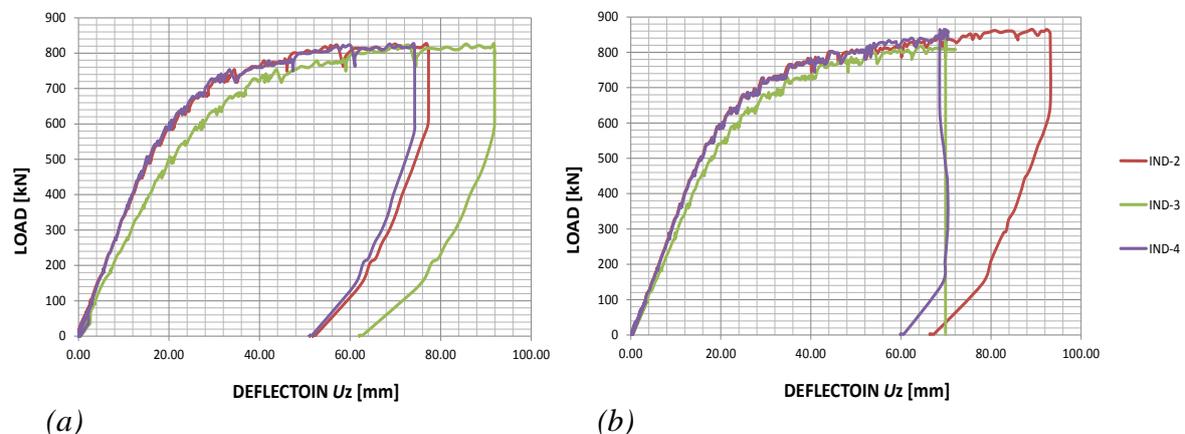
Fig. 11: Typical experimental load–deflection curves for (a) specimen O2 (‘isolated’ rebars) and (b) specimen O3 (‘non-isolated’ rebars)

Interestingly, the behaviour illustrated in terms of load-deflection curves seems very similar for both types (*Fig. 11*), without any significant drop in stiffness and strength. The transition from elastic to plastic behaviour is smooth, and the effect of the failure of the bond appears undistinguishable.

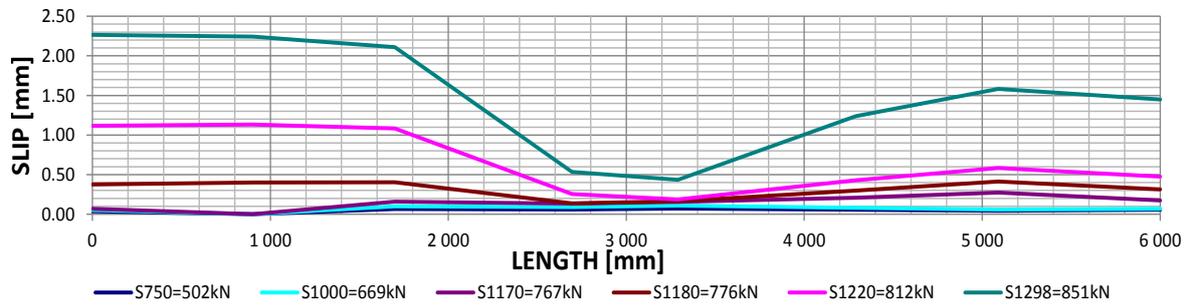
Fig. 12: Typical distribution of the slip along the beam length at various load levels

In the following Fig. 12, a typical distribution of the slip deformations along the beam length at different load levels is illustrated (specimen O3). Similar pictures are obtained for all the specimens.

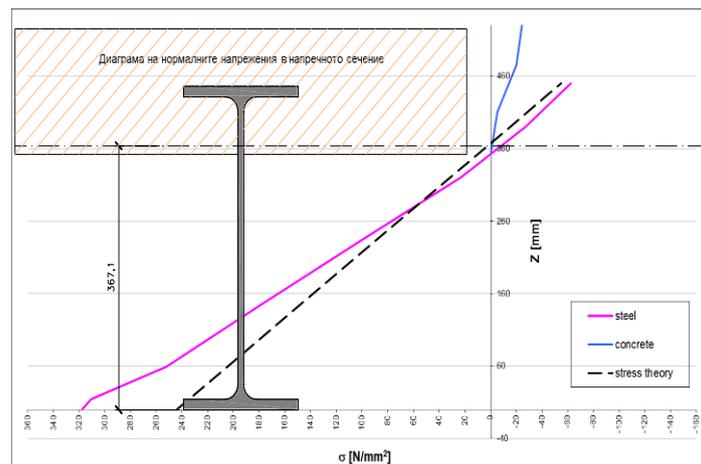
Fig. 13(a): Stress distribution at first yield of steel, specimen O1, $M = 460 \text{ kNm}$

Other important results expected from the experimental programme are on the bending resistance of the partially encased composite beams at ultimate limit state. The following figures illustrate the stressed state observed for two specimens in elastic and plastic stage. In Fig. 13 the results are obtained for specimen O1 with ‘isolated’ transversal reinforcing bars, while in Fig. 14 the results present the stressed state in specimen O3.

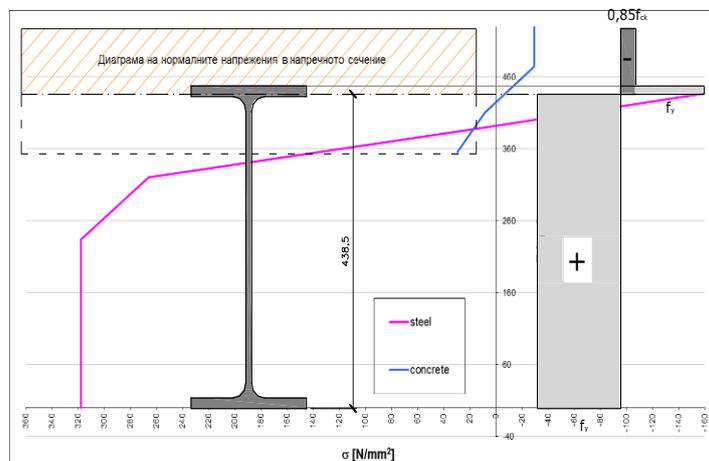
Fig. 13(b): Stress distribution at maximum load, specimen O1, $M = 770 \text{ kNm}$

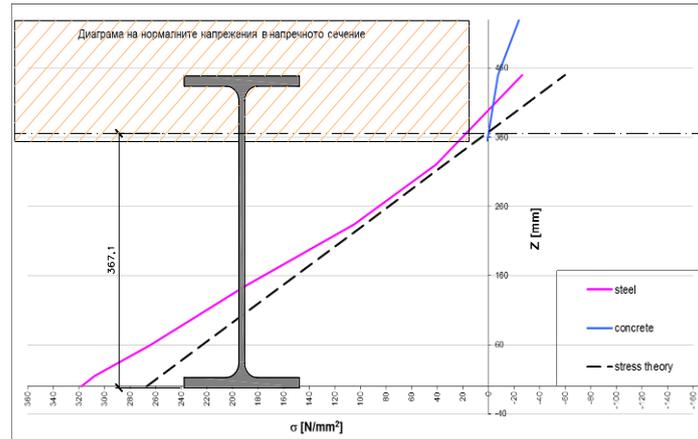
Fig. 14(a): Stress distribution at first yield of steel, specimen O3, $M = 502 \text{ kNm}$

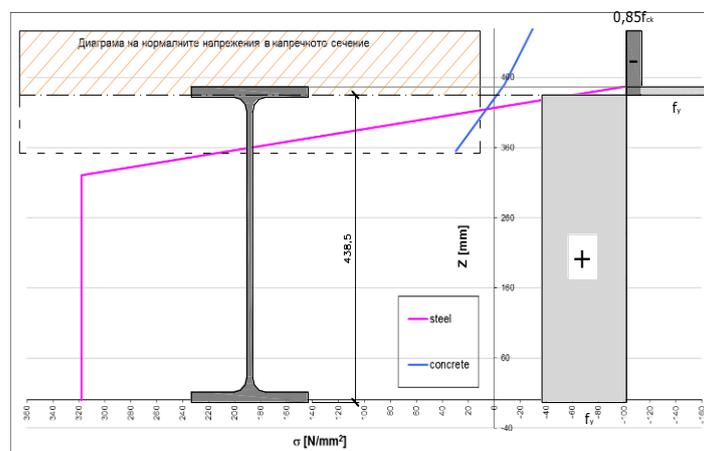
Fig. 14(b): Stress distribution at maximum load, specimen O3, $M = 864 \text{ kNm}$

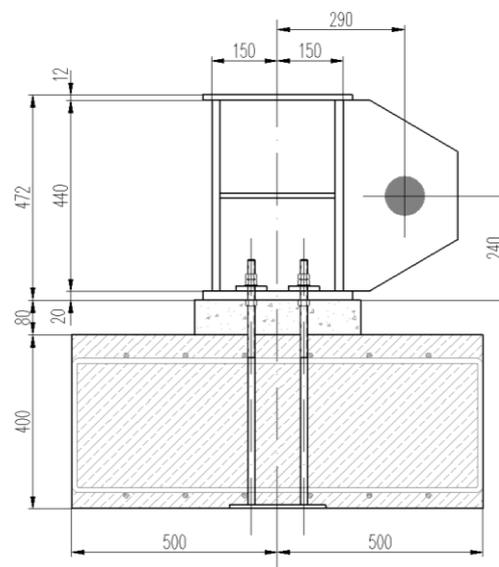
Fig. 15: Test specimens

The test specimens were designed so as to represent the behaviour of typical nominally pinned column bases. Four specimens were fabricated all having the same dimensions as shown in *Fig. 15*. The column stub was adopted relatively strong (HEB300) to avoid any significant premature deformations in the column and to provoke the failure in the base connection itself. The anchor bolts were 4Ø16, embedded in reinforced concrete foundation blocks. The latter were anchored to the laboratory strong floor. The anchor bolts were fabricated of round steel S235JR with cut threads. The foundations were cast in place in the laboratory using commercial ready-mixed concrete specified as grade C25/30 (though it appeared to correspond to C30/37). The anchor bolts were sufficiently embedded in the concrete to prevent any type of brittle failure (pullout, breakout, pryout or blowout) of concrete.

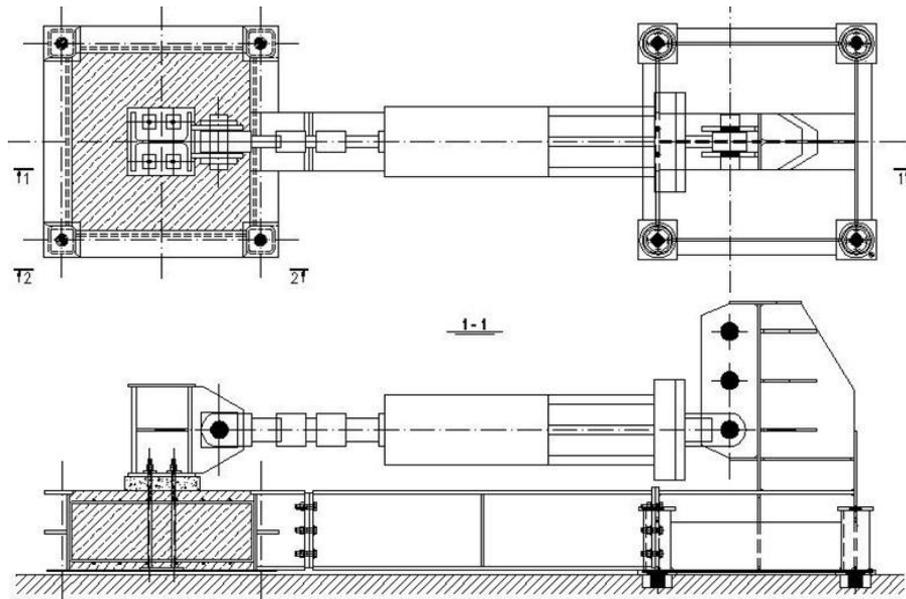
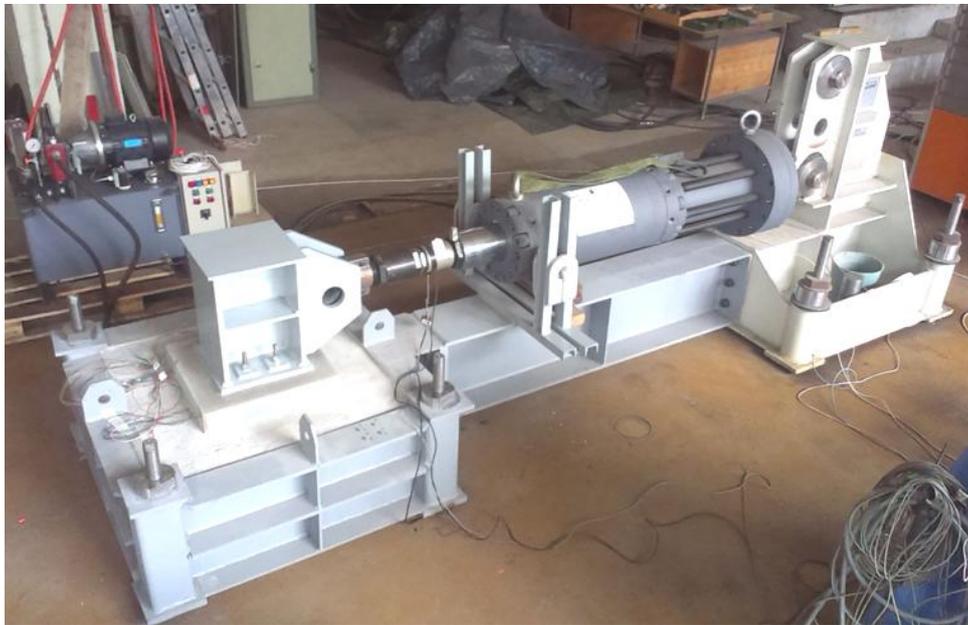
Fig. 16: Column base test setup

The experimental setup is shown in *Fig. 16*. The load was applied by a 500 kN hydraulic actuator at 240 mm above the base plate to simulate large shear load plus a relatively small moment, thus representing the actual partially restrained behaviour of a nominally pinned column base. No vertical load was applied to exclude the contribution of the friction between the base plate and the grout.

Oversized bolt holes in the base plates were used as in the typical practice in Bulgaria, with additional plate washers for the anchor bolts welded to the base plate to minimize the slip before the shear load was transferred to all bolts.

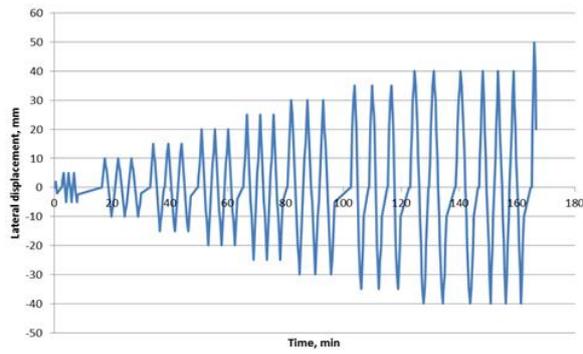
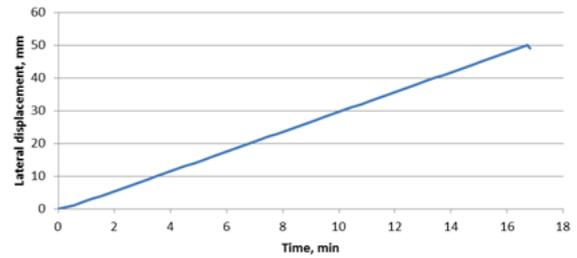
Fig. 17: Loading protocols: (a) cyclic with full reversals; (b) monotonic

Two types of loading protocols were used (*Fig. 17*). For the cyclic tests the basic recommendations of ECCS “Experimental Assessment of Seismic Strength and Ductility of Structural Elements and Connections” were generally observed. The specimens were tested under displacement control (imposed displacements), with three or more complete reversal cycles at each displacement level. It is worth noting that comparable loading histories have been used in other similar experimental studies [12, 13]. The static tests were performed under monotonically increasing displacement.

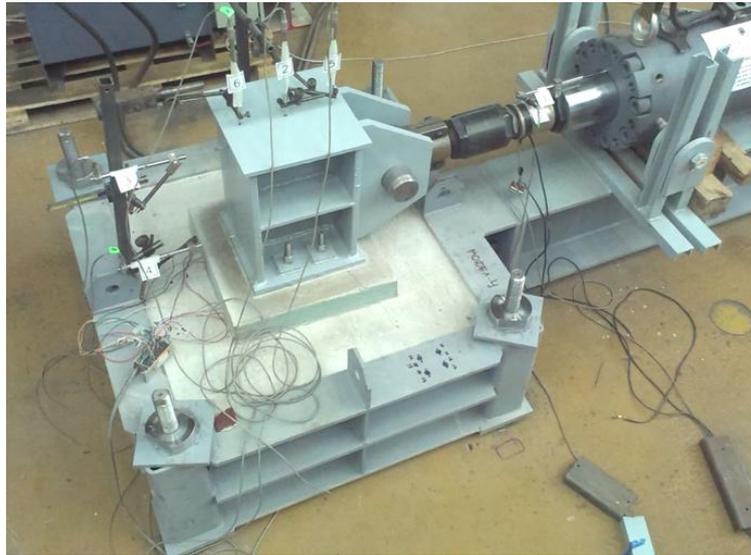
Fig. 18: Test setup – instrumentation

A total of six displacement transducers were attached to the column base to measure displacements in lateral and vertical directions. Additionally, two strain gauges were attached to each anchor bolt in the portion between the top of the concrete surface and the bottom of the base plate, i.e. within the grout bedding layer. A typical instrumentation layout is illustrated in *Fig. 18*.

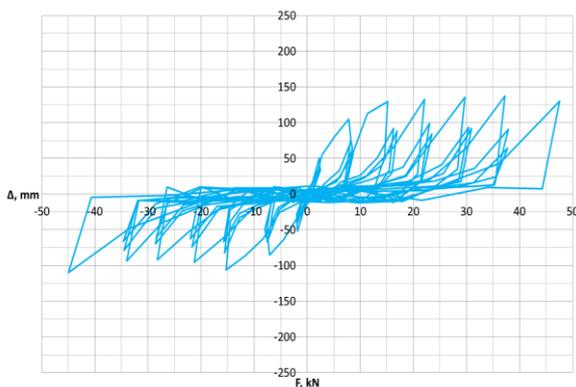
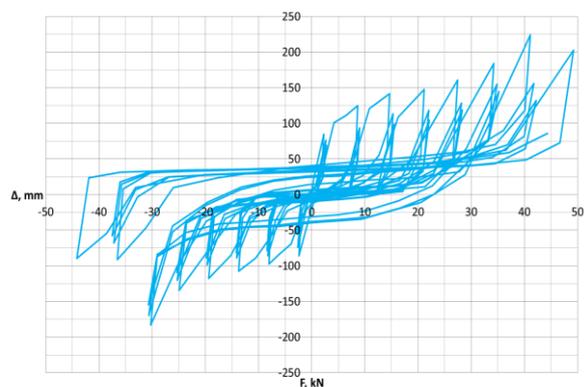
Fig. 19: Load–displacement plots, cyclic tests: (a) regular grout; (b) FRG

The test results are presented in terms of relationships between the lateral force, F , and the horizontal displacement, Δ . The load–displacement plots are shown in Fig. 19 for the two specimens subjected to cyclic loading. The same plots obtained for the other two specimens under monotonic tests are given in Fig. 20.

In the cyclic tests both specimens (regular grout and FRG) exhibited similar hysteretic loops with well pronounced pinching effect. At the beginning of the test the anchor bolts were loaded predominantly in shear. However, with increasing the applied displacements, due to the bending moments, separation of the base plate from the grout occurred on the tension side and a new mechanism of shear transfer was formed. The shear force seemed to be transmitted mostly by shear in the anchor bolts in the compression zone as well as by friction between the base plate and the grout. Significant bending of the anchor bolts also occurred.

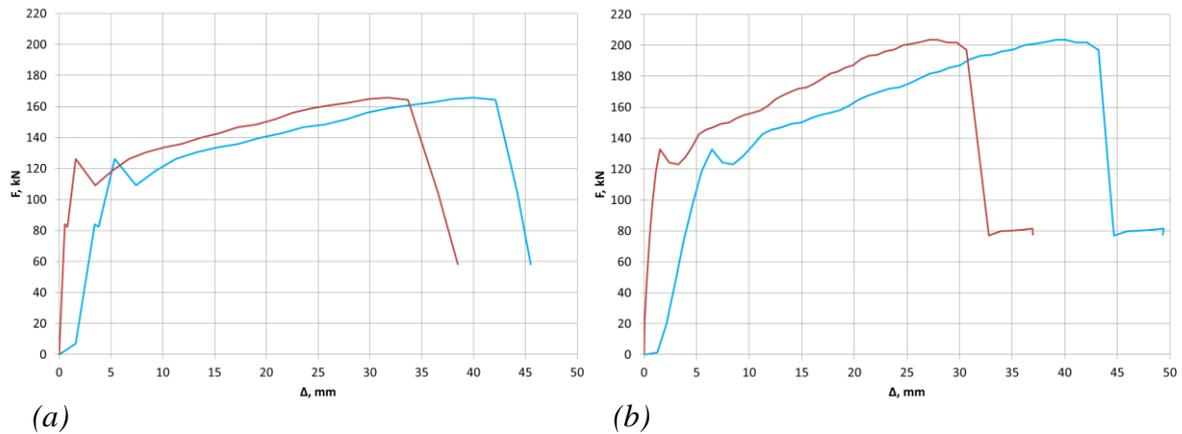
Fig. 20: Load–displacement plots, monotonic tests: (a) regular grout; (b) FRG

In the monotonic tests, similar behaviour has been observed for both specimens. As seen in Fig. 20, the initial stiffness in the elastic range of anchor bolts and the ‘elastic’ strength of both specimens seem quite similar. A drop in the strength occurred in both cases when the

anchor bolts yielded. However, the post-elastic behaviour differs substantially due to the different shear transfer mechanisms as described above. The ultimate loads were 166 kN in the case of ordinary grout and 204 kN for the fibre-reinforced grout.

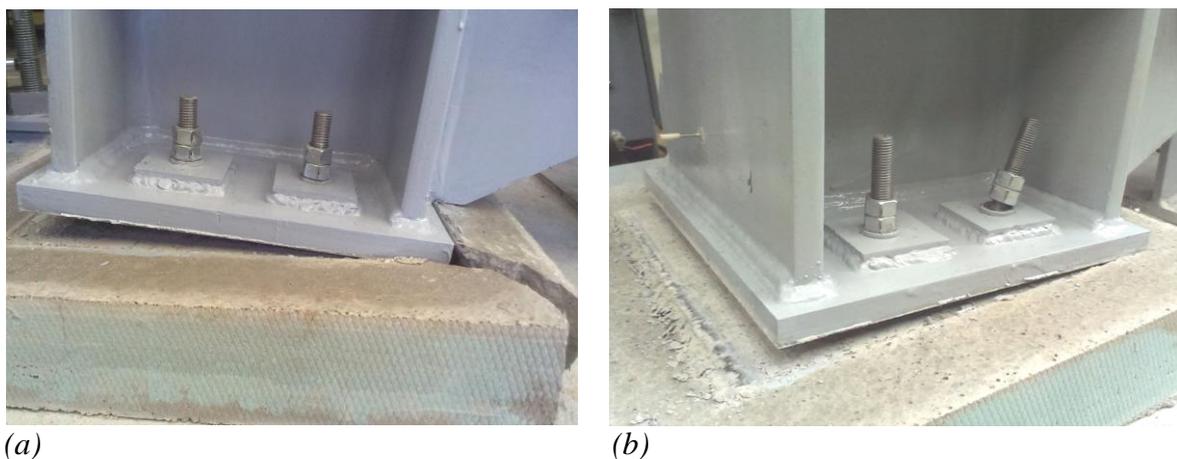
Fig. 21: Failure mechanisms: (a) regular grout; (b) fibre-reinforced grout

Finally, different failure mechanisms were observed in the two specimens. In the case of ordinary grout, a large crack formed around the anchor bolts which gradually increased and led to splitting of the grout bedding (Fig. 21a). On the contrary, in the case of FRG, due to the higher strength of the grout, the collapse was due to the anchor bolts failure after yielding, therefore the failure mode was proved to be more ductile (Fig. 21b). The total number of cycles was 27 while in the case of regular grout it was 22. The difference in the maximum loads at failure was quite substantial: 137/110 kN (in both directions) in the case of ordinary grout versus 225/183 kN for the fibre-reinforced grout, i.e. more than 60%.
