NUMERICAL STUDY OF THE THERMAL BEHAVIOUR OF STEEL MEMBERS WITH DAMAGED SFRM COATINGS

1. ABSTRACT

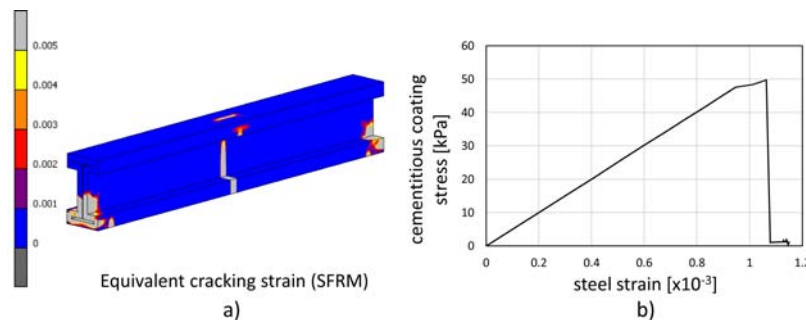
Fig. 6: a) Equivalent cracking strain at the SFRM coating, b) SFRM stress vs steel strain at the middle of bottom flange

Mechanical failure of the SFRM coating occurs much later, in the form of a transverse crack in the middle of the beam, initiating at the bottom of the lower flange, extending upwards along the coating of the web and reaching the top flange (*Fig. 6,a*). The crack appears when $v/L = 2.32‰$, long after the extensive failure of the interface bond which occurs at $v/L = 0.89‰$. Steel strain at the occurrence of the crack is $1.07‰$ (*Fig 6,b*), a value that is in quite good agreement with the axial test results which showed that the SFRM coating failed at steel strains of 1.2 ‰. The damage that occurs at the SFRM

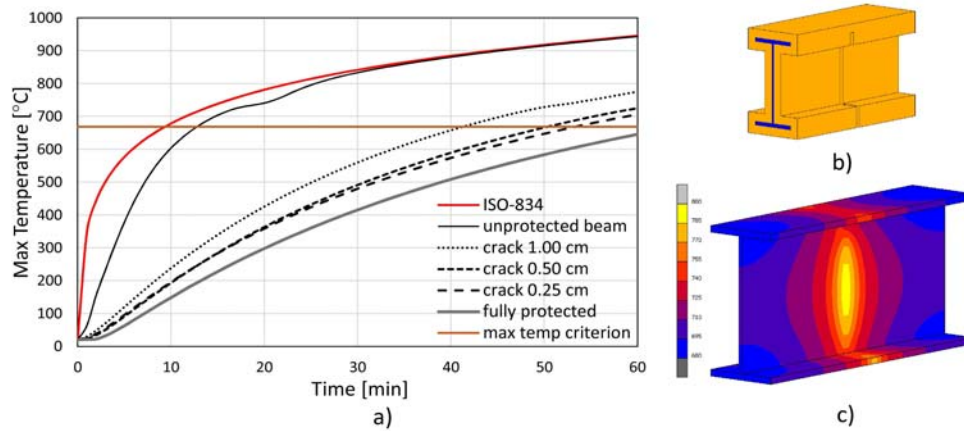
Fig. 7: a) Maximum temperature evolution of steel for the parametric models, b) FEM model with crack c) Temperature distribution in the steel beam

For the thermal analysis, only a part of the beam is modelled, which extends 0.20m on either side of the middle of the beam (*Fig. 7,b*). The insulated steel beam is subjected to external thermal loading and the heat is transferred to the steel beam and the SFRM coating through radiation and convection. At the interface, the two materials are considered to have the same temperature. The radiation heat transfer is implemented in the model through a radiating surface (emissivity = 1) placed opposite the coating, along the outer perimeter of the section, which undergoes a temperature rise according to the ISO-834 curve. The heated surface radiates to the coated, or the uncoated steel (crack), taking into account the corresponding view factors. Natural convection is modelled by a surface film applied on the corresponding exposed SFRM coating or steel opposite the radiating areas, using a heat transfer coefficient for air of 25 W/m²·°K.

The evolution of the maximum temperature of the steel beam for the simulated models is given in *Fig 7,a*. Along with the temperature time histories, the ISO-834 time-temperature curve and the failure criterion of single point maximum temperature (20+649=669°C) for unrestrained steel beams according to ASTM-119 [6] are given. A representative temperature distribution in the steel beam is given in *Fig. 7,c*.

The results of the maximum temperature evolution in the steel beam, indicate that even a small crack, of 0.25cm, can affect the temperature development in an SFRM insulated steel section. In the specific case of the IPE200 beam, the 0.25cm crack on the coating reduces the fire resistance of the beam by 7 minutes, according to the ASTM-119, single point criterion, and a crack of 1cm, reduces the fire resistance by 19 minutes, which is about 1/3 less compared to the undamaged SFRM coated section. It is also evident, however, that an

unprotected beam will fail after only 13 minutes of ISO-834 thermal exposure, underlining the significance of fire the insulation of steel structural members.
