CONSTRUCTION OF THE STEEL DOME OF THE MULTIPURPOSE AL-SADD SPORTS HALL IN DOHA, QATAR

1 SUMMARY

The present paper presents the methodology for the construction of the steel dome of the Al-Sadd sports hall in Doha, Qatar. Certain decisions concerning the construction of the steel roof had as a result the temporary modification of the concrete structural system on which the steel roof is supported. For this reason, an extensive study was performed in order to verify that the unavoidable increase of the design magnitudes remained within acceptable levels. The paper presents in detail the construction methodology and describes the methodology that was followed for the verification, which included staged nonlinear analysis. In order to minimize the impact of the erection methodology, temporary measures were taken (back propping in certain areas and temporary braces to increase the lateral stiffness).

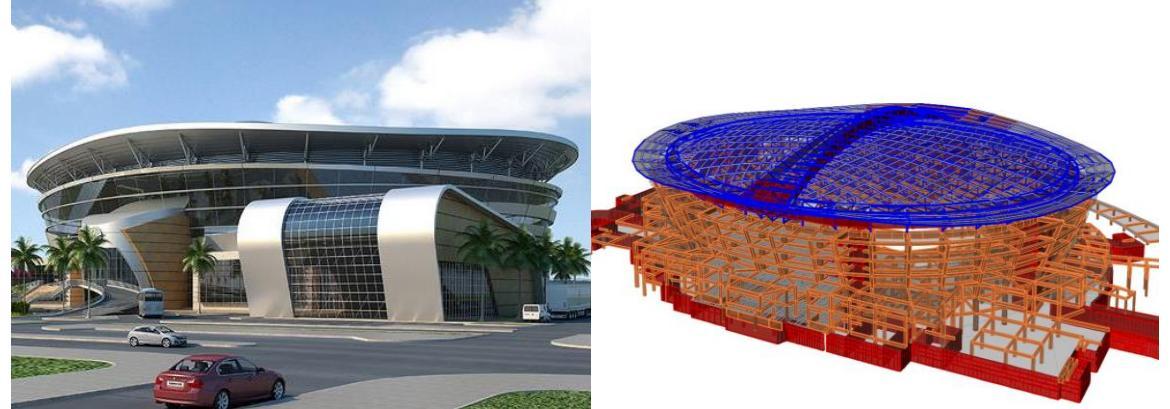
Figure 1. Architectural 3D rendering and the 3D structural analysis model of the stadium

on the concrete elements of the 5th floor. Figure 1 presents a 3D rendering of the finished building and the complete structural analysis model.

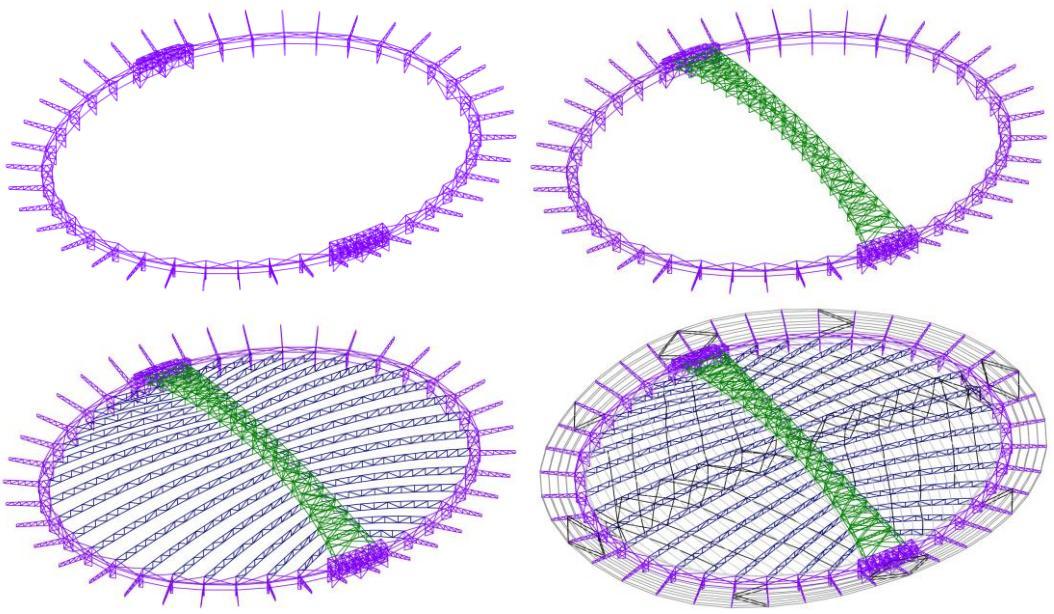
Figure 2. The components of the steel roof

The steel dome is roughly composed by (see Figure 2):

- a stiff perimetric ring supported on concrete
- a central arch having a length of about 100m
- secondary trusses, which are supported on the perimetric ring and on the central arch
- purlins and bracings that ensure the spatial stability of the whole steel structure.

The erection methodology was dominated by the decision for the construction and erection of the central arch. This component (see Figure 2) had a length of roughly 100m and a weight of 270t. Due to the large dimensions and weight and the height above ground that it had to be installed, the erection was not possible in multiple pieces in a propped configuration. For this reason, a large part of the central arch, having a length of 75m and a weight of 185t was constructed as a single piece on the floor of the sports hall and was elevated at the foreseen position using hydraulic jacks. Due to this operation, the concrete structure (including the raker beams) was only partially constructed in order to give the necessary space for the construction and elevation of the central arch (Figure 3).

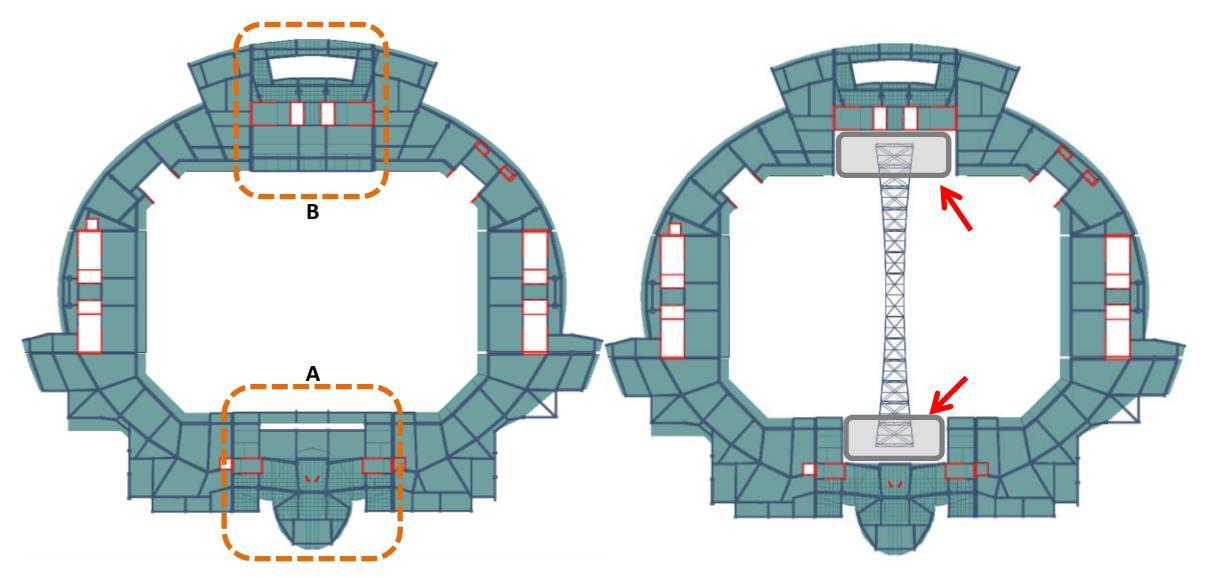
Figure 3. Parts of the concrete structure that were not constructed so that the main arch could pass through and elevated into the final position.

Preliminary analyses showed that the strength of the concrete structure was significantly affected by the erection methodology, as large parts of the statically independent Sections A and B (Figure 3), contributing to the lateral stiffness, could be constructed only after the finalization of the steel erection. The most significantly affected components were the core walls of Sections A and B. Therefore, specific measures had to be taken in order to reduce the stressing of these walls. To this end, an extended area was propped (see dots in the sketches of Figure 4). The props were positioned in all the floors, starting from the foundation level (back propping), prior to the casting of the 5th floor slab. Moreover, in Section A, temporary bracings were installed between certain concrete columns, in order to increase the lateral stiffness of the concrete structure. The positions where the temporary bracings were installed are shown in Figure 4. Both the temporary bracings and the props were removed after the completion of the erection of the steel roof.

- 1. Construction of the concrete parts till the 4th floor in Sections A and B, with the exception of the areas indicated with arrows in Figure 3.
- 2. Back propping of the areas indicated in Figure 4.
- 3. Casting of the concrete structure of the 5^{th} floor in Sections A and B.
- 4. Installation of the temporary bracings indicated in Figure 4.
- 5. Completion of the concrete construction till 5th floor, all around the stadium.
- 6. Installation of the perimetric ring steel structure.
- 7. Installation of the main steel arch.
- 8. Installation of the secondary trusses together with the required for stability roof bracings (Figure 6).
- 9. Completion of the concrete construction of the omitted parts in Sections A and B.
- 10. Removal of the back propping and temporary bracings
- 11. Completion of the steel construction (installation of purlins, cladding, etc).

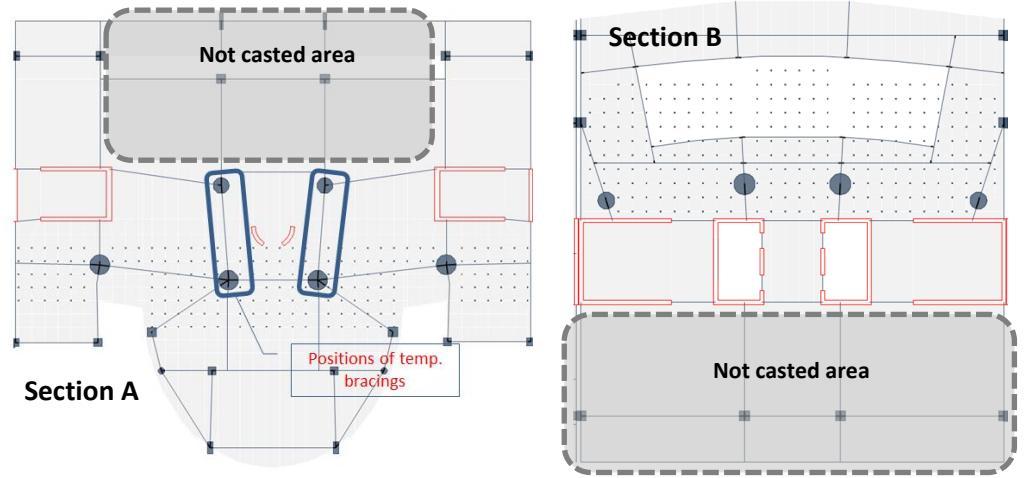
Figure 4. Pack-propping positions in Parts A and B and positions of temporary bracings in Part A.

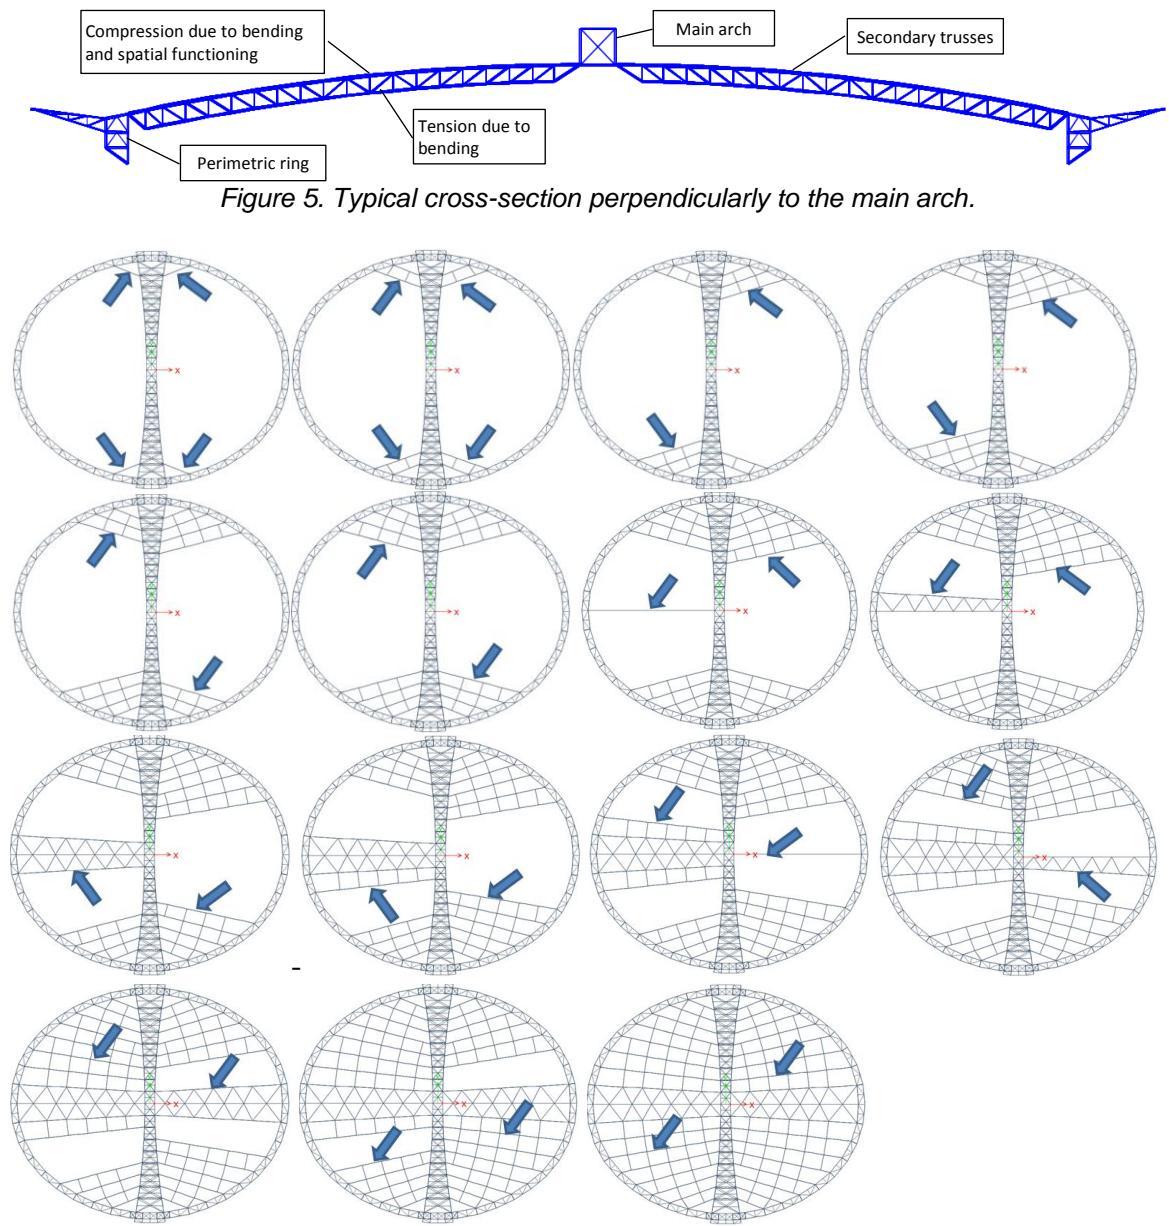
Figure 6. Installation sequence of secondary trusses.

when installed start receiving loads from the additional roof components installed afterwards, by means of developing compressive forces at the upper chord (in addition to the compressive forces coming from bending). Therefore, the section forces that develop at the secondary trusses depend on the specific installation sequence and this stressing is different from the one that develops if it is considered that the self-weight is applied on the completed structure (normal design assumptions). Moreover, an asymmetric installation procedure that would be advantageous from the viewpoint of minimization of the crane movements (e.g. installation of the east secondary trusses first and then installation of the west ones), concludes to significant asymmetries of the section forces. For the above reasons, an extended study was performed in order to determine a sequence that would lead to overall stressing close enough to the one that occurs under normal design assumptions. Finally, the study concluded to the installation sequence presented in Figure 6, which was optimized also for two cranes operating simultaneously. Together with the secondary trusses, parts of the bracing system were also installed so that the completed parts are always adequately supported laterally.

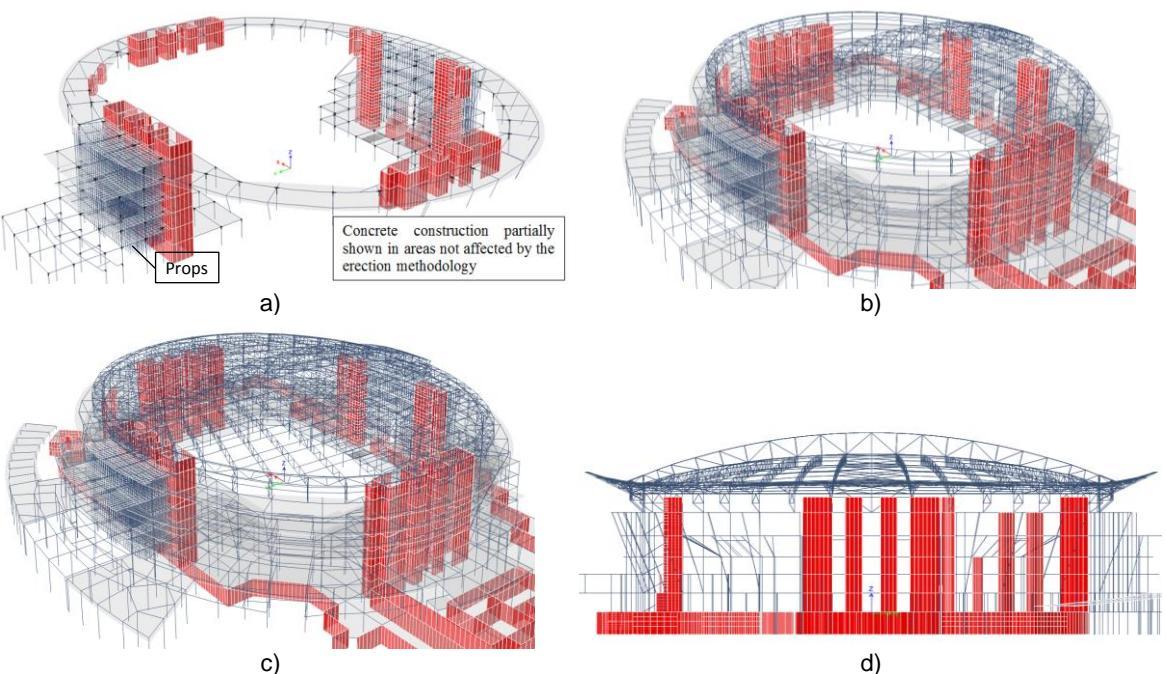
Figure 7. Snapshots of the different structural systems that were considered.

For the above reasons, it was decided to proceed to a complete verification of the structural members that would take into account all the specific steps of the erection procedure, using nonlinear staged analysis. According to this procedure, multiple structural systems were considered, each corresponding to a real construction stage. The self-weight of the structural elements was applied on a different structural system, corresponding to the actual configuration of the structure. At the end of the procedure, the stress vector that was obtained for the self-weight load case contained the contribution from all the different (temporary) structural systems. Figure 7 presents characteristic snapshots of the analysis process. In Figure 7a (in which some concrete elements have been hidden for clarity) the introduction of the props can be noticed, prior to the casting of the 5th floor slabs. Figure 7b corresponds to the installation of the main arch, after the perimetric steel ring has been completed. Figure 7c displays the structure after the completion of the roof, prior to the removal of the props.

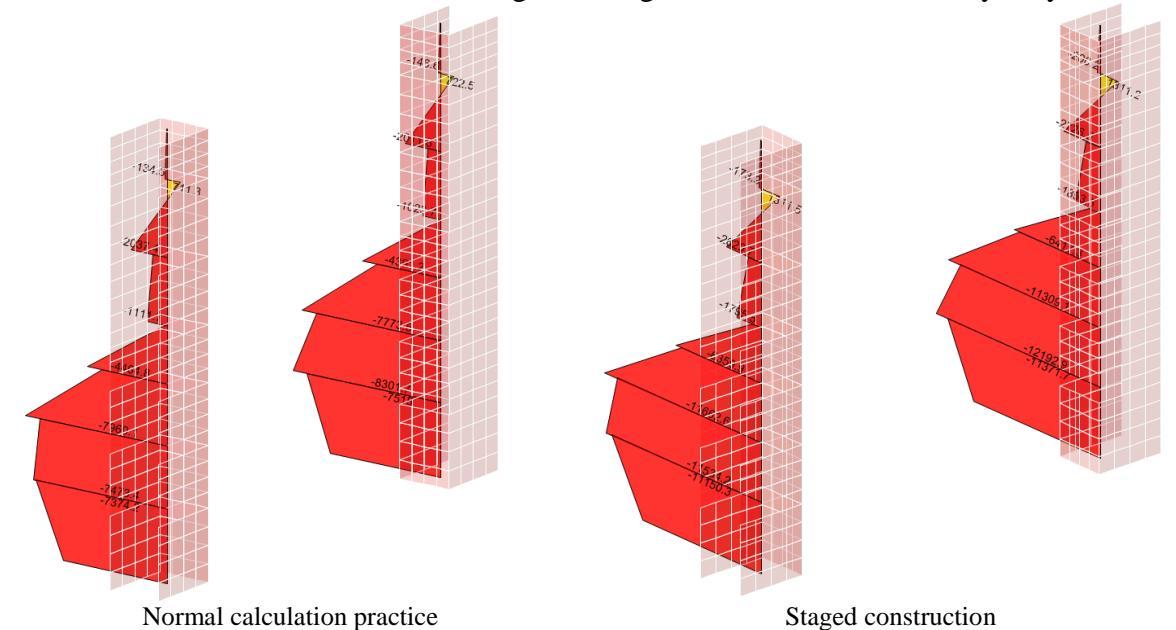
Figure 8. Bending moments of core walls of Section A due to self-weight.

As an example of the extra stressing that the construction methodology causes to the core walls and of the procedure that was followed, the case of the core walls of Section A is presented. Figure 8 presents the bending moments of the core walls due to self-weight as they are calculated applying the normal calculation practice (load applied on the completed structure) and applying the staged construction methodology. It is noticed that there is an increase of the bending moments due to the specific methodology followed, by roughly 45%. Moreover,

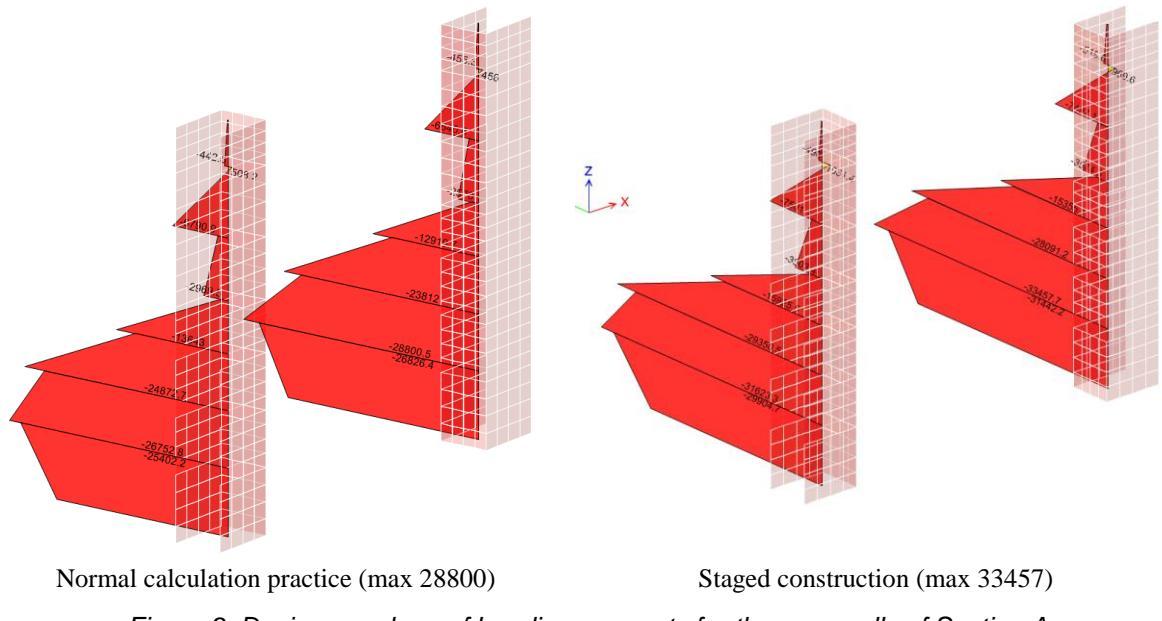
Figure 9. Design envelope of bending moments for the core walls of Section A.

Figure 9 presents the enveloping values of the **design** moment that correspond to the two calculation cases. It is noticed that design bending moments are increased by only 16.5%

Moreover, the verification of the core walls (comparison between the reinforcement requirements and the installed reinforcement) led to the conclusion that the highest strength utilization factor was of the order of 85%, therefore, despite the increased design magnitudes, the core walls had a significant margin from failure.
